# Customizing Home Retrofits

**Dan Sandink**  
Manager of Resilient  
Communities and  
Research,  
Institute for  
Catastrophic Loss  
Reduction (ICLR)

Flood mitigation efforts need to account for individual differences in each home, neighbourhood and municipality.

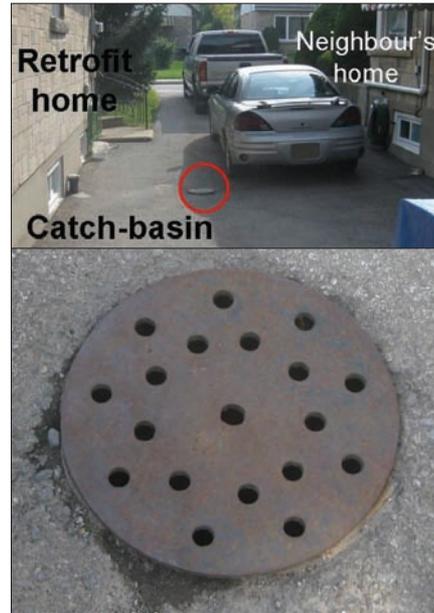
tating installation of additional measures to reduce risk. This catch-basin was connected to the home's foundation drainage; surprisingly, it served to drain the neighbour's driveway, which was sandwiched between the two homes (See Figure 1 above). The catch-basin essentially transformed the neighbour's driveway into a huge funnel that directed massive quantities of rainwater into the foundation drainage and risked overloading of the sump pit and pump during heavy rainfall events.

ICLR installed a second, large-capacity sump-pit and pump, as well as re-graded a part of the front yard to direct as much water away from the driveway catch-basin as possible. An automatic natural gas generator that could power the pumps in the event of a power outage

was also installed. Had the catch-basin not been there, a simple backwater valve/sump pump arrangement would likely have been sufficient for the home, along with other relatively simple measures, including window well covers and disconnecting downspouts.

The Hamilton case study shows the need to balance the cost and benefits of mitigation measures, since it is sometimes difficult to implement perfect or ideal mitigation options in homes. For that home, ICLR explored the possibility of re-grading the neighbour's driveway and installing a permeable pavement system. This would have allowed us to eliminate the need for the catch-basin.

However, to implement this approach, huge quantities of fill would have had to be brought in to re-grade the driveway, causing significant disruption for the homeowner and neighbours. It would have also resulted in a cost in the tens of thousands of dollars.

We decided a second sump, a powerful pump and generator system, was a reasonable compromise.

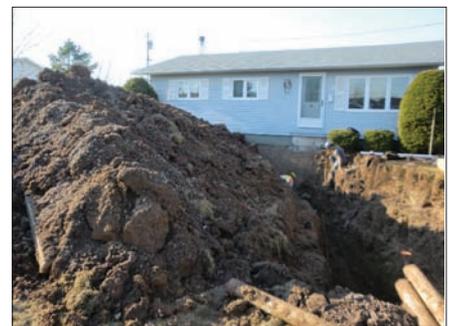
Figure 2

Two surprises were waiting for us in this home. First, when the plumbers conducted the camera inspection of the laterals on the day that the backwater valves were to be installed, they found that both laterals were full of standing water and sewage. Normally, sewer laterals are graded in a manner that directs

water away from the home quickly; they should never have any standing water. Based on the camera inspection, and before the backwater valves were installed, the laterals had to be torn up and replaced, requiring the excavation of the front yard (See Figure 2).

Further, in the Moncton home, backwater valves would have been ineffective — and may have even increased flood risk — if they were installed in the laterals when the laterals were full of standing water. In this case, replacement of the laterals was absolutely necessary to ensure the backwater valves would work properly.
