ICLR Commercial Bulletin

## Fire following earthquake and high-rise buildings

## Consider secondary water supply for high-rise buildings

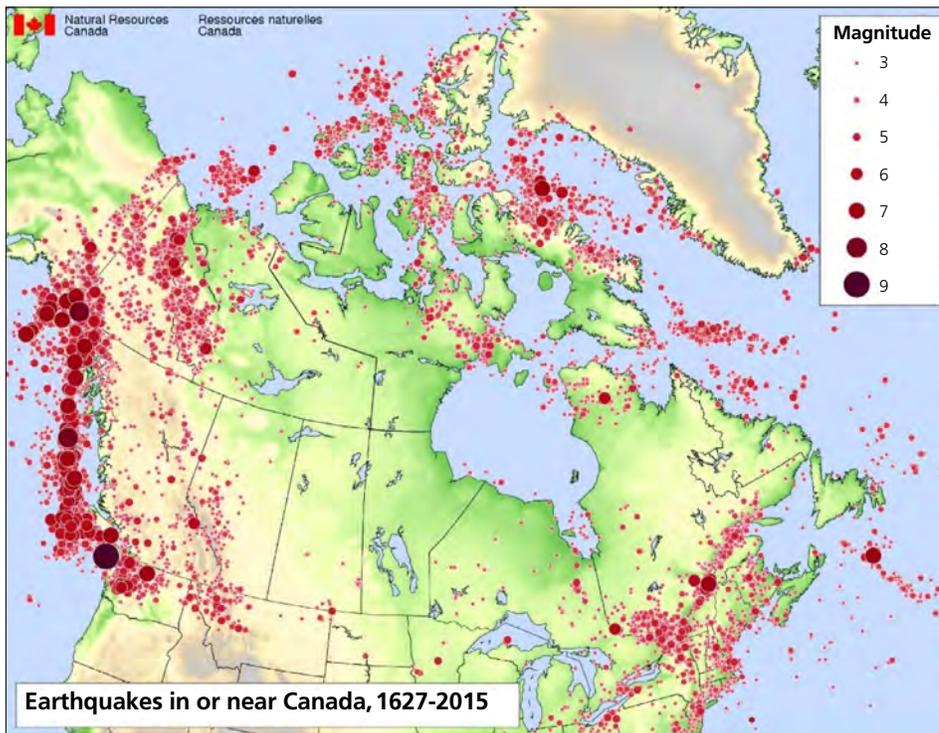
**Historical seismicity of Canada.**  
(Source: Geological Survey of Canada)

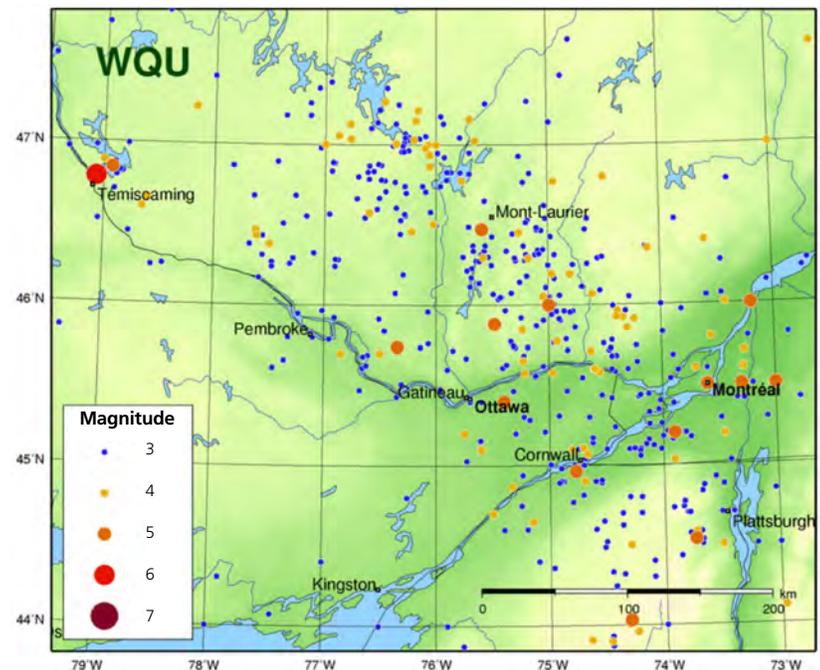
**The pattern of historical seismic activity recorded by the Canadian seismograph network since the beginning of the century shows the earthquakes concentrating in two sub-zones: one along the Ottawa River and the second along a more active Montreal-Maniwaki axis.**  
(Natural Resources Canada, Earthquake Zones in Eastern Canada)

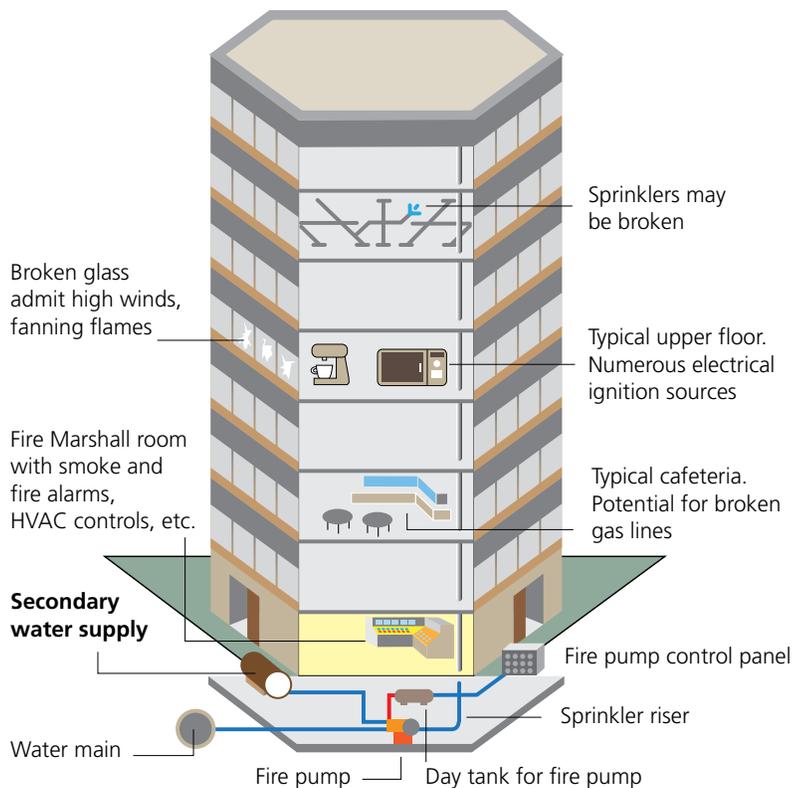
**High-rise building and post-earthquake fire aspects. Secondary water supply is required in seismic zones in U.S. because it is anticipated water mains may fail. If mains fail, sprinklers have no supply (Scawthorn 1989).**

High-rise buildings are particularly vulnerable to fires at all times and fire departments depend to a great extent on sprinkler systems. However, sprinkler systems in Canada typically depend on the underground water distribution system for supply and, if that system fails in an earthquake, sprinklers will be left without water and fires can grow unimpeded.

Because of the risk of fires in high-rise buildings after an earthquake, building codes in the United States for decades have required high-rise buildings in high seismic zones to have a secondary water supply, typically a 60,000-litre tank located in the basement or mechanical room near the backup fire pump.

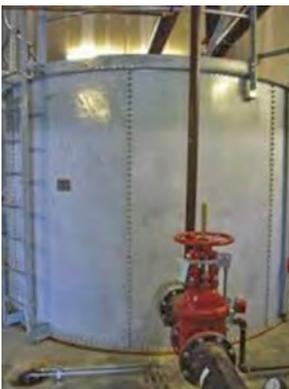
**Example of a 60,000 litre (15,000 gallon) steel secondary water supply tank. Tanks such as these are commonly anchored to the floor to prevent them from sliding or tipping during an earthquake.**

Barring formalized building code changes (and to be sure to consider existing construction) ICLR encourages owners/managers of high-rise buildings that are located in high seismicity zones to consider voluntarily installing tanks and the necessary pumps and other equipment to ensure that high-rises have adequate access to emergency firefighting water in the event that the primary firefighting system fails in an earthquake.
