ICLR Commercial Bulletin

ISSUE 4 • MAY 2022

Fire following earthquake and high-rise buildings

Consider secondary water supply for high-rise buildings

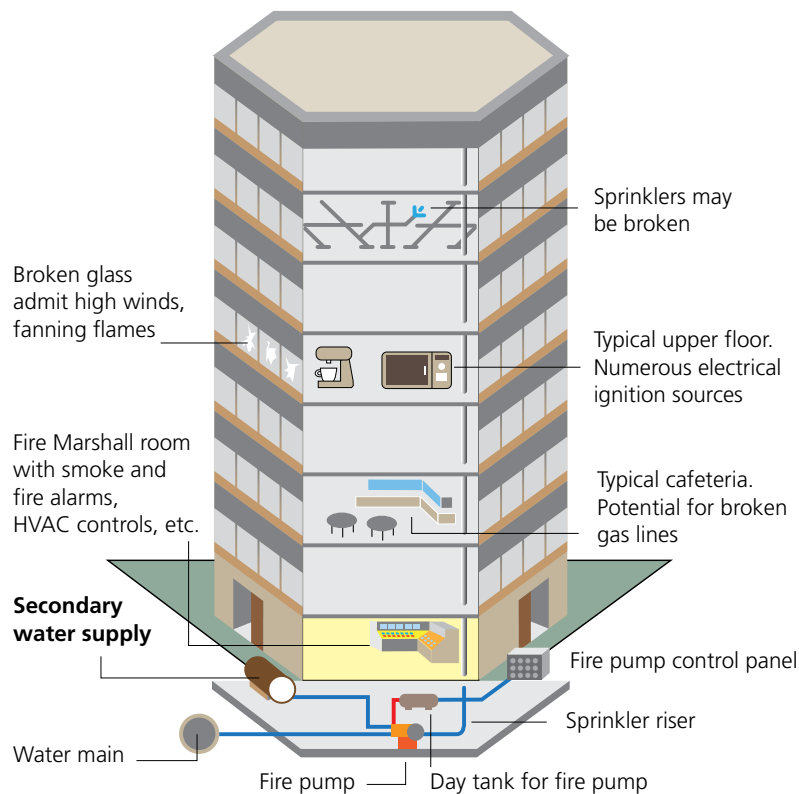
High-rise building and post-earthquake fire aspects. Secondary water supply is required in seismic zones in U.S. because it is anticipated water mains may fail. If mains fail, sprinklers have no supply (Scawthorn 1989).

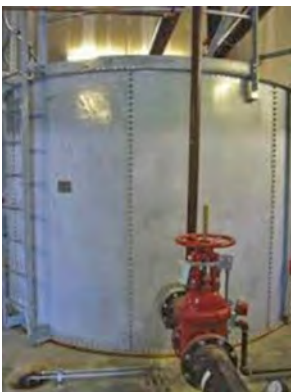
Example of a 60,000 litre (15,000 gallon) steel secondary water supply tank. Tanks such as these are commonly anchored to the floor to prevent them from sliding or tipping during an earthquake.

Because of the risk of fires in high-rise buildings after an earthquake, building codes in the United States for decades have required high-rise buildings in high seismic zones to have a secondary water supply, typically a 60,000-litre tank located in the basement or mechanical room near the backup fire pump.

Barring formalized building code changes (and to be sure to consider existing construction) ICLR encourages owners/managers of high-rise buildings that are located in high seismicity zones to consider voluntarily installing tanks and the necessary pumps and other equipment to ensure that high-rises have adequate access to emergency firefighting water in the event that the primary firefighting system fails in an earthquake.
